Manhole Inspection Summary

Manhole # S31E__042MH

Location Address: **side of 112 n eutaw st**

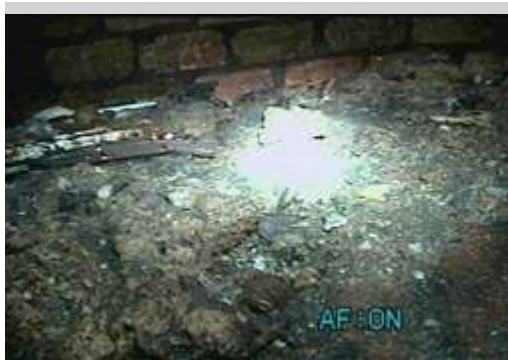
Defect 4

Condition: ☐ Sound ☐ Cracked ☐ Root Intrusion ☐ Deteriorated ☐ Leaks ☒ **Debris**

bench debris

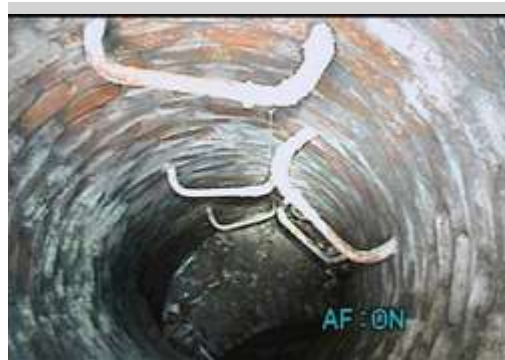
Defect 3

Steps Count: **6** Missing: **0** ☒ **Corroded**

steps

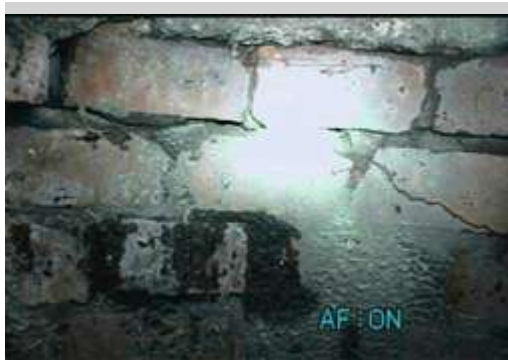
Defect 2

Condition: ☐ Sound ☒ **Cracked** ☐ Root Intrusion ☐ Loose Brick ☐ Deteriorated

cracked corbal

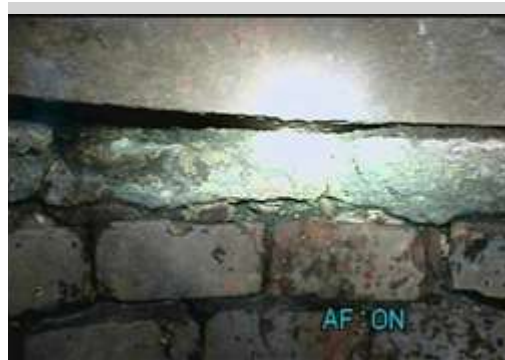
Defect 1

Condition: ☐ Sound ☐ Cracked ☐ Root Intrusion ☐ Loose Brick ☒ **Deteriorated**

chimney deteriorated

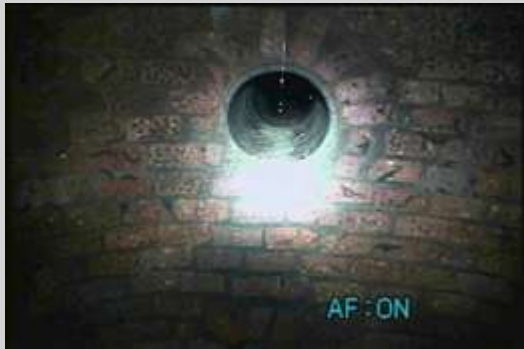
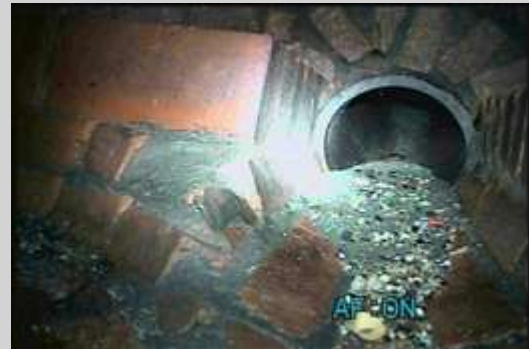
8 O'Clock Inflow

Deposits: ☐ None ☐ Mud ☐ Sludge ☒ **Debris** ☐ Grease

Silt Depth: **1.5** (in.) Deposits Extent: **Light**

Drop: **Outside** **Direct**
